Forensic Report Accident Uber-Volvo 18.03.2018 (Extract from Research Project Car-Forensics)

Forensic Report Accident Uber-Volvo 18.03.2018 in Tempe, Arizona (USA)

Release date: 02 April 2018

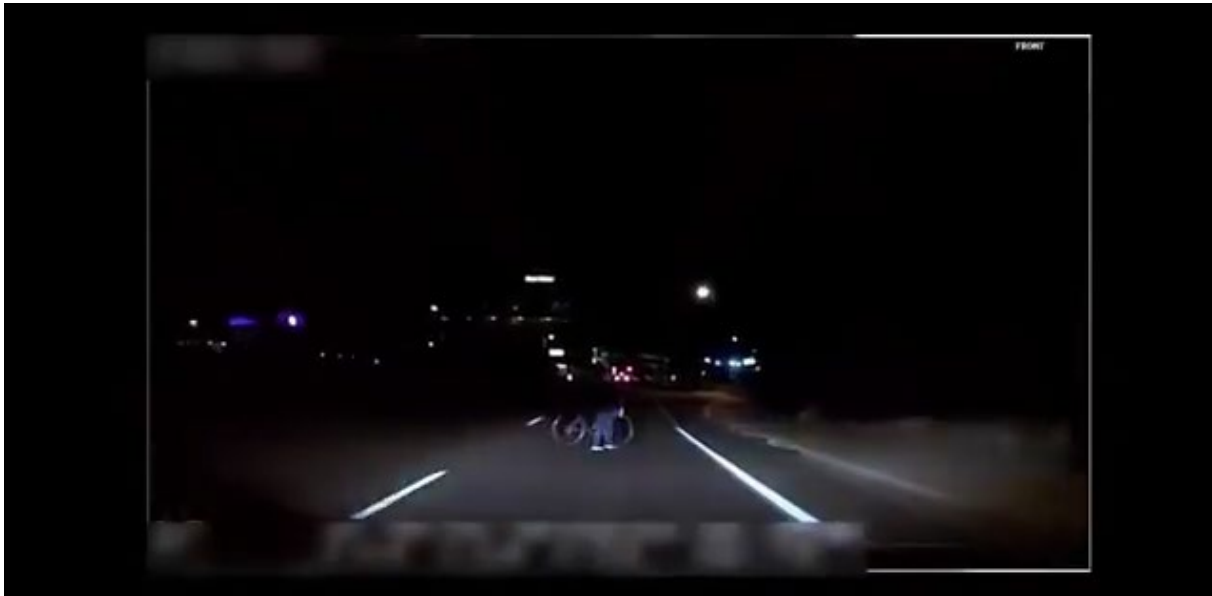
Illustration 2: Cutout Dashcam video (source YouTube - resolution 636 x 360 px)

It is particularly noticeable after a first sighting of the video material freely available on the Internet about the crash that the picture of the front camera is very dark and the pedestrian actually seems to emerge from the shadow just before the collision. This initially nourishes the thesis that the accident would have been unavoidable even for a human driver:

Attempts to whitewash the video through post-processing filters fail because of the poor quality of the source material. In all sources accessible on the Internet, the additional information is also pixelated at the edge of the picture. The author has therefore contacted the police in Tempe, Arizona and asked to be sent the original images from the press release. In fact, one day after his request he received a better quality version with a resolution of 848 x 480 and 25 fps, which also contained the additional information in plain text without pixels (front camera):

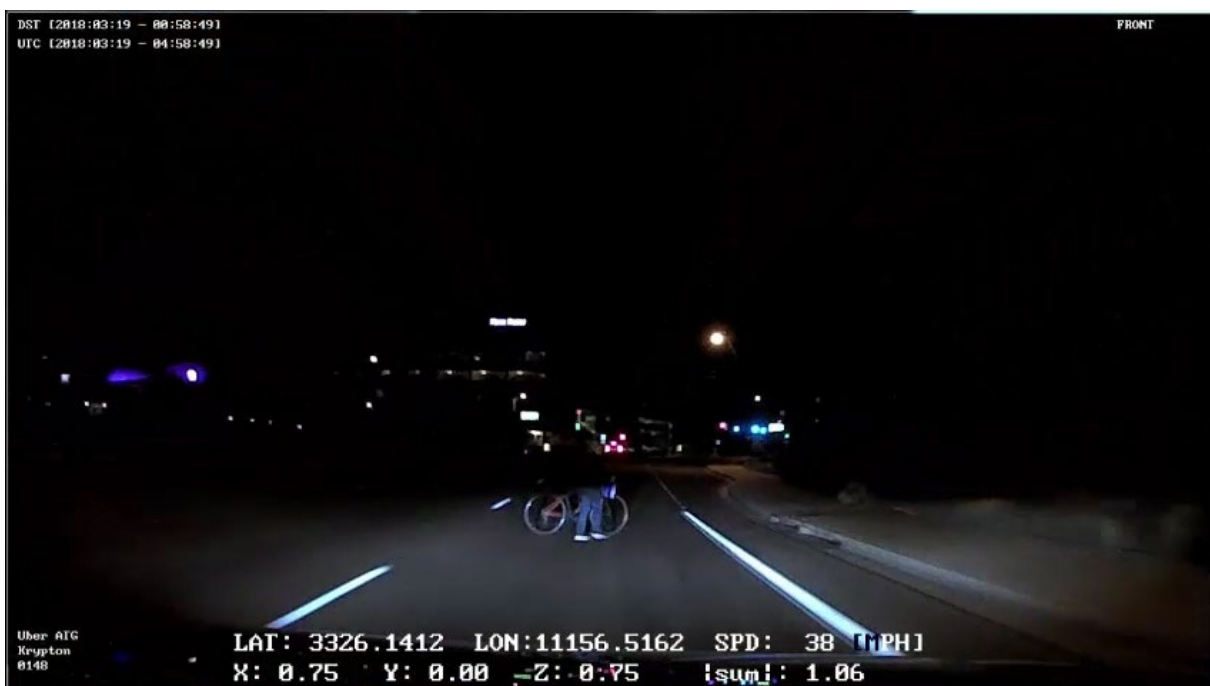
Illustration 3: Cutout Dashcam video (source police Tempe - resolution 848 x 480 px)

Unlike the shortened video on YouTube, the video starts sooner (just before the bridge is undercut), so important details become visible for further analysis.

First, it is striking that the interface between the outside and inside view and at the end of the video briefly, the background image of the Windows Media Player is visible. If one compares its quality (and brightness) with that of a screenshot on the author's evaluation PC after playing the original video, one recognizes that the latter is qualitatively clearer and a little brighter. This leads to the conclusion that the police has not evaluated the original video from the vehicle or distributed, but this was recorded and cut from a PC presumably using a screen recorder. In the process and the subsequent export of the edited video material, it seems that there has been a loss of quality. It is even conceivable that the original video was filmed with a video camera or a smartphone. That would then be an extremely negligent and unprofessional procedure with regard to the evaluation.

Extremely questionable is why not the digital output file was used in the highest possible resolution. One could assume that the video was deliberately played on a PC and this brightness or quality reductions were deliberately or at least negligently accepted.

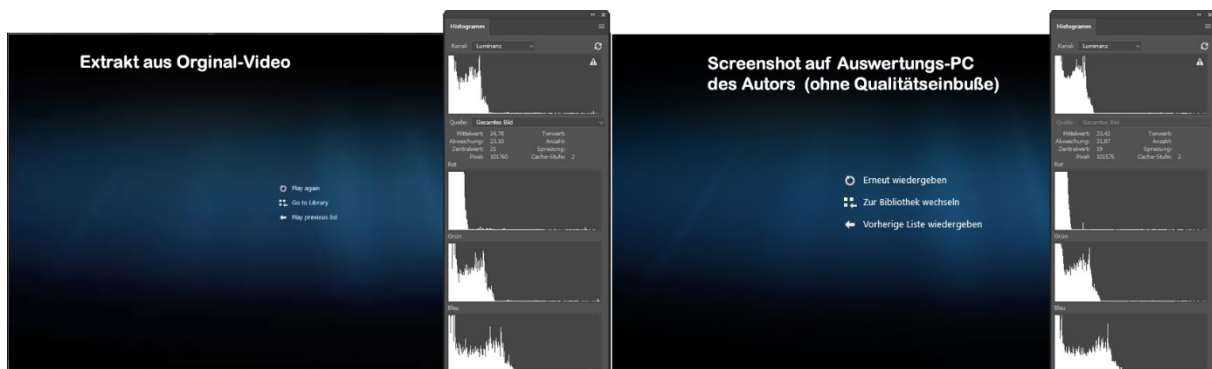
Illustration 4: Compare reduced quality police video to possible resolution / brightness

The histograms show the slightly higher dynamics of the screenshot (right) with less noise compared to the video provided by the police (left).¹⁰

Should the video still depict the real lighting conditions 1:1, this would in turn mean that the visibility has reached only to the limit of the driving light (here dipped beam). Since you can only drive so fast that you can stop the vehicle at any time within sight, this would mean that you would have to drive much slower in these light conditions. The visibility can be measured on the median strip in the video and the comparison with Google Earth to about 25 m. This in turn leads to a maximum permissible speed of 45 km / h (equivalent to 28 mph) for conventional assumptions (1 s reaction time, 6 m / s² deceleration on dry asphalt)¹¹.

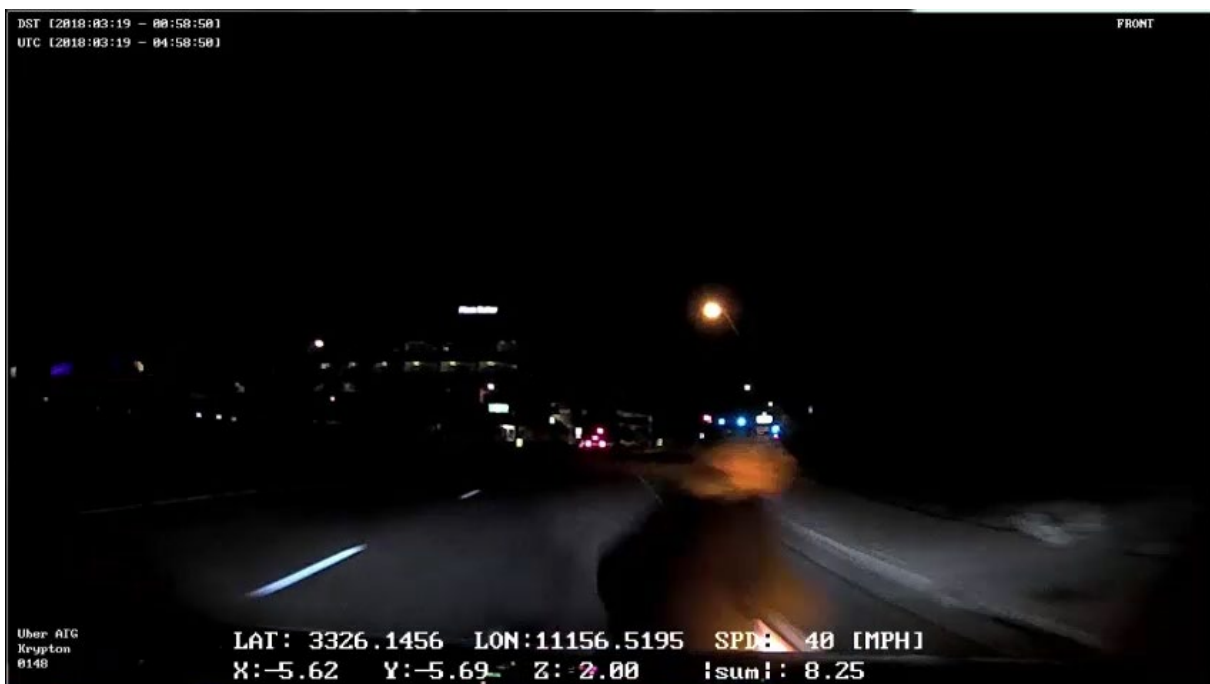
Illustration 6: Picture from the police video immediately after the impact

From the metadata contained in the image border one can read off further information and further process it for the evaluation. Thus, the time stamp shows that the accident took place on 18/03/2018 at 04:58:50 UTC (corresponds to 00:58:58 local time) in the geographic coordinates LAT 3326.1456 LON 11156.5195 at a speed of 40 mph¹³:

The values X, Y and Z presumably indicate the acceleration in the longitudinal and transverse axis or vertically downward (gravitational acceleration) and the value "sum" is used to determine a vector sum (mathematical magnitude) for the resulting acceleration. At 8.25 m / s² this value is significantly higher than the normal values during a journey and indicates the impact.

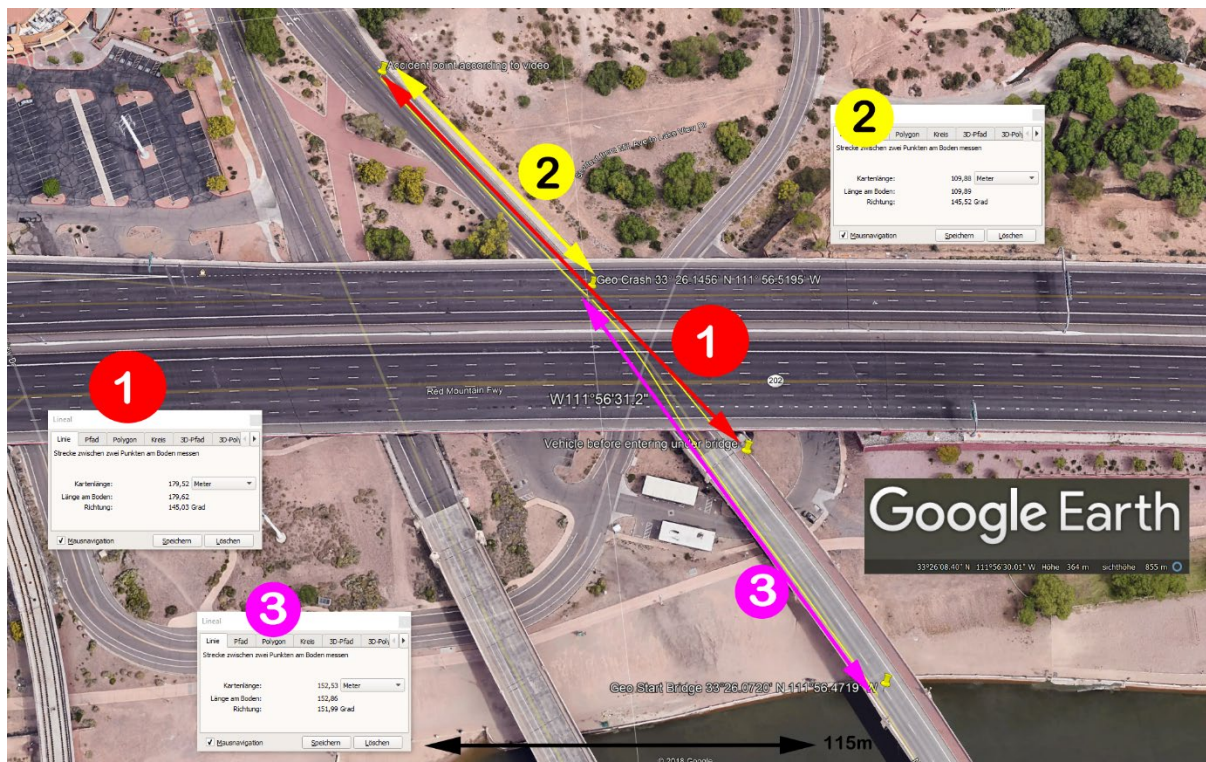
Illustration 7: Deviation alleged geo-position to actual position

If one interprets the values as degrees, minutes, seconds and in this case the seconds as a decimal value, this leads to $33^{\circ} 26' 14.56''$ N $111^{\circ} 56' 51.95''$ W. These values lie about 500 m away from the actual accident location. This is significantly more than the usual error of the GPS signal of less than 15 m.

However, if you interpret the values as degrees and minutes and the minutes as a decimal value with decimal places, this leads to $33^{\circ} 26.1456'$ N $111^{\circ} 56.5195'$ W. This value is plausible because it lies on the vehicle's travel path. However, the distance to the actual accident point at this time is approx. 108 m.

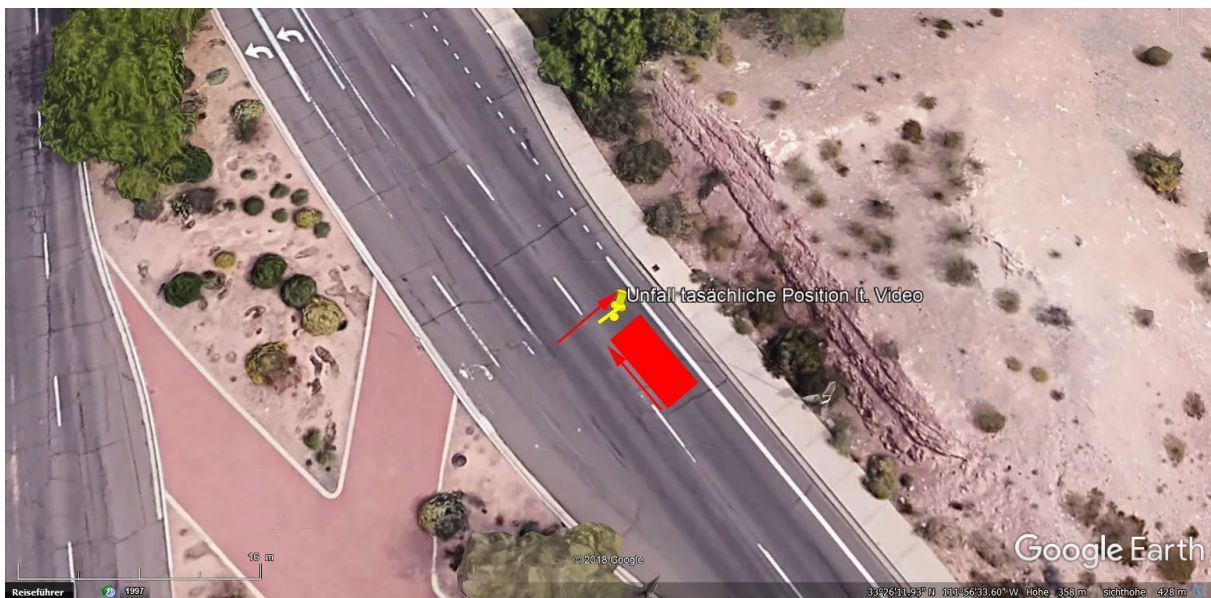
Illustration 8: Mapping the accident using Google Earth

The metadata contained in the video should therefore be handled with the utmost care - also with regard to the presumed calculated speed. This obviously refers to the area before driving under the bridge. In this area, a speed limit of 35 mph applies up to the bridge, which makes the calculated value v_{Geo} of 34 mph plausible. The deviation or offset by approx. 76 m or 108 m on the driving beam is due to a delayed calculation of the speed based on outdated GPS data by a few seconds. The speed measured by GPS is always calculated from two previous geo positions and the time required for this. If the values are updated slowly, the thus determined speed always corresponds to that before x seconds. Using the video you can determine the coordinates of the impact very accurately by comparing the lane marking with the images from Google Earth:

If one measures in the video the time, which needed the vehicle shortly before the accident for the departure of the distance of 6 middle trace marks, then this leads to a higher speed:

That means the vehicle has had a speed of about 45 mph in the last 70 m before the impact. According to the video (metadata), the vehicle accelerated in this area from 34 mph to about 40 mph directly on impact and then increased the speed to 42 mph after the accident. The latter is completely implausible, since that would mean that the car would have accelerated again when hitting the victim. In fact, it will have been slowed down by the impact. The findings on the previous page also explain this apparent contradiction. The speed values shown in the video, in contrast to the acceleration values X, Y and Z detected in real time, are outdated by several seconds and refer to the roadway about 76 m to 108 m further ahead of the accident. It is also plausible that the vehicle accelerated there, as the speed limit was raised from 35 mph to 45 mph from the time the bridge was driven under, as shown immediately.

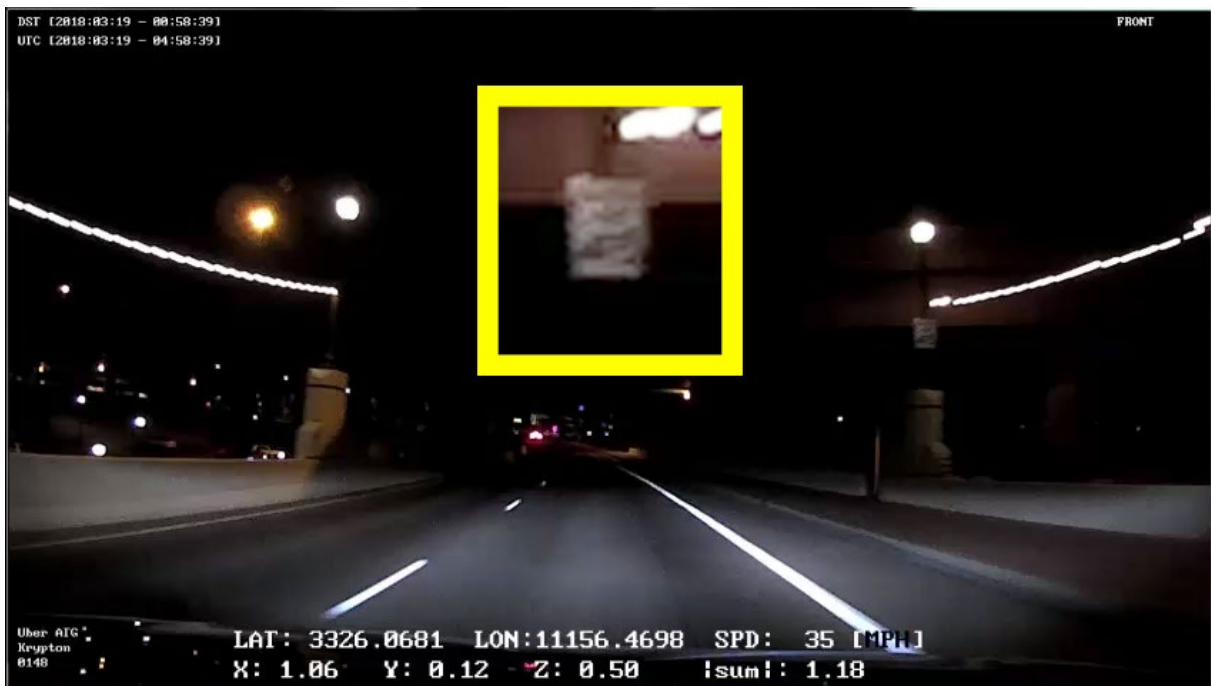
Illustration 13: Recording of the 45 mph shield from the accident car

There are three proofs to the contrary, which all show that at this point 45 mph is the permitted limit and that the vehicle was not traveling too fast:

However, even on the accident video, the 45 mph sign is easily recognizable:

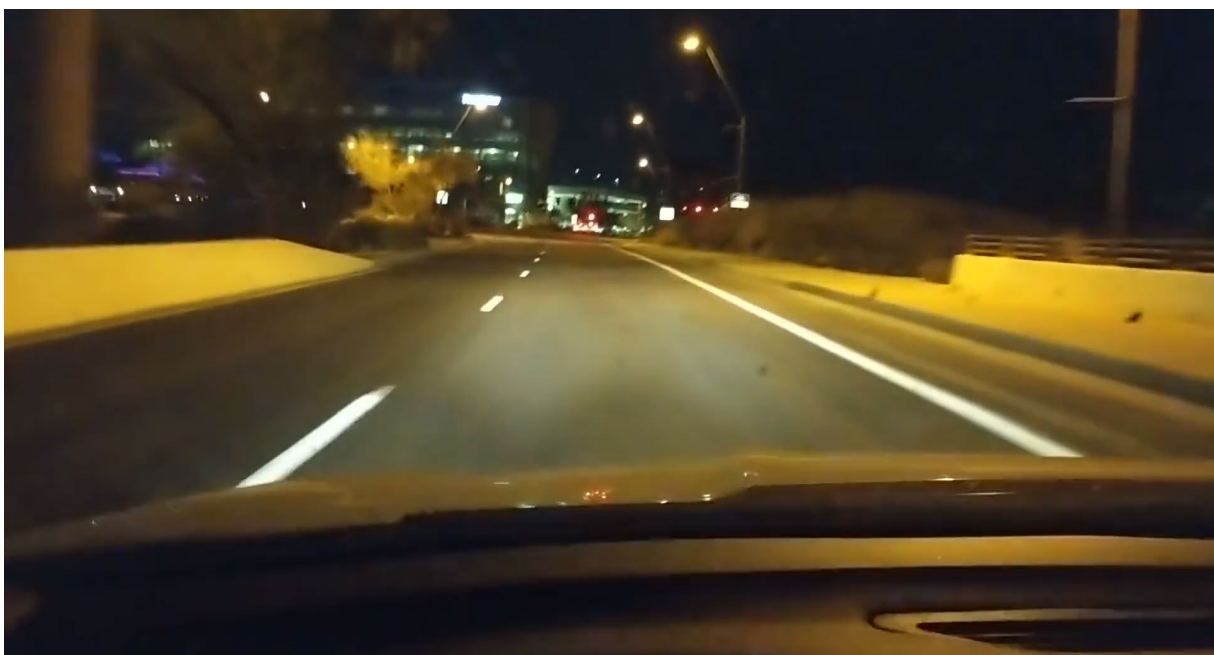
Illustration 16: Actual light situation at the accident site at night about 120 m before the accident

However, the video by Brian Kaufmann provides a much more important insight. The visual situation at night is not nearly as dark as the video broadcast by the police shows:

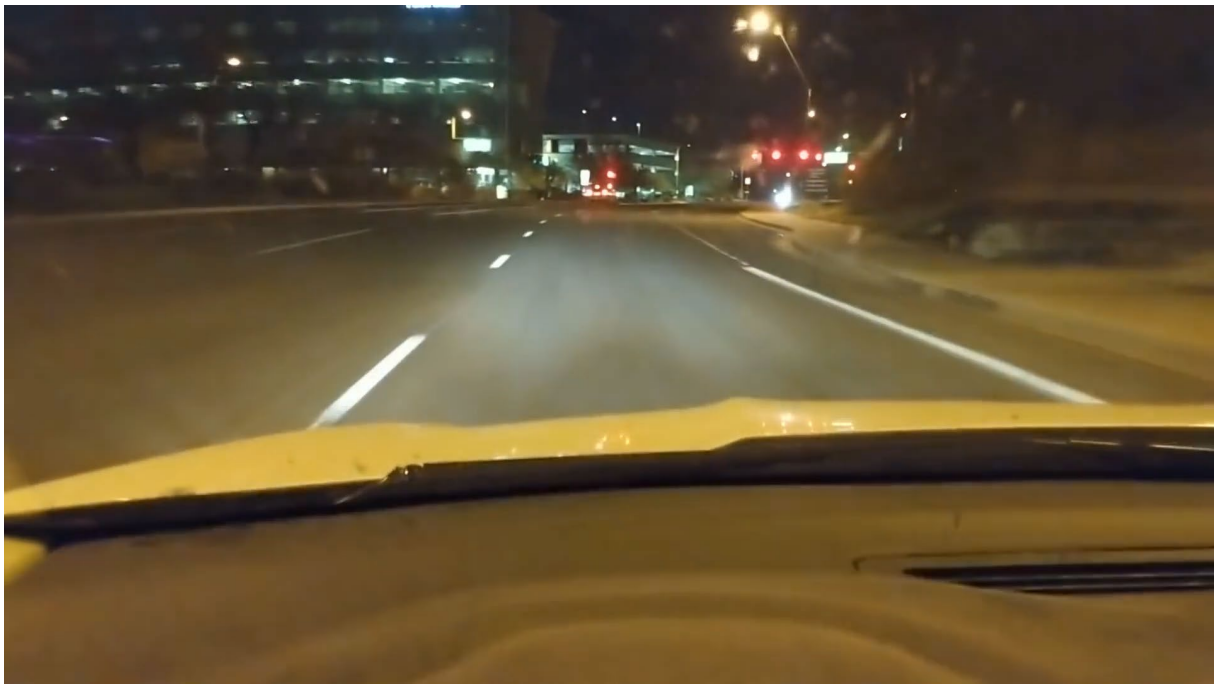
Illustration 18: Actual light situation at the scene of the accident

It can be clearly seen that the entire street is very well lit and an obstacle, such as a person crossing a bicycle pushing a bicycle would be easily recognizable.

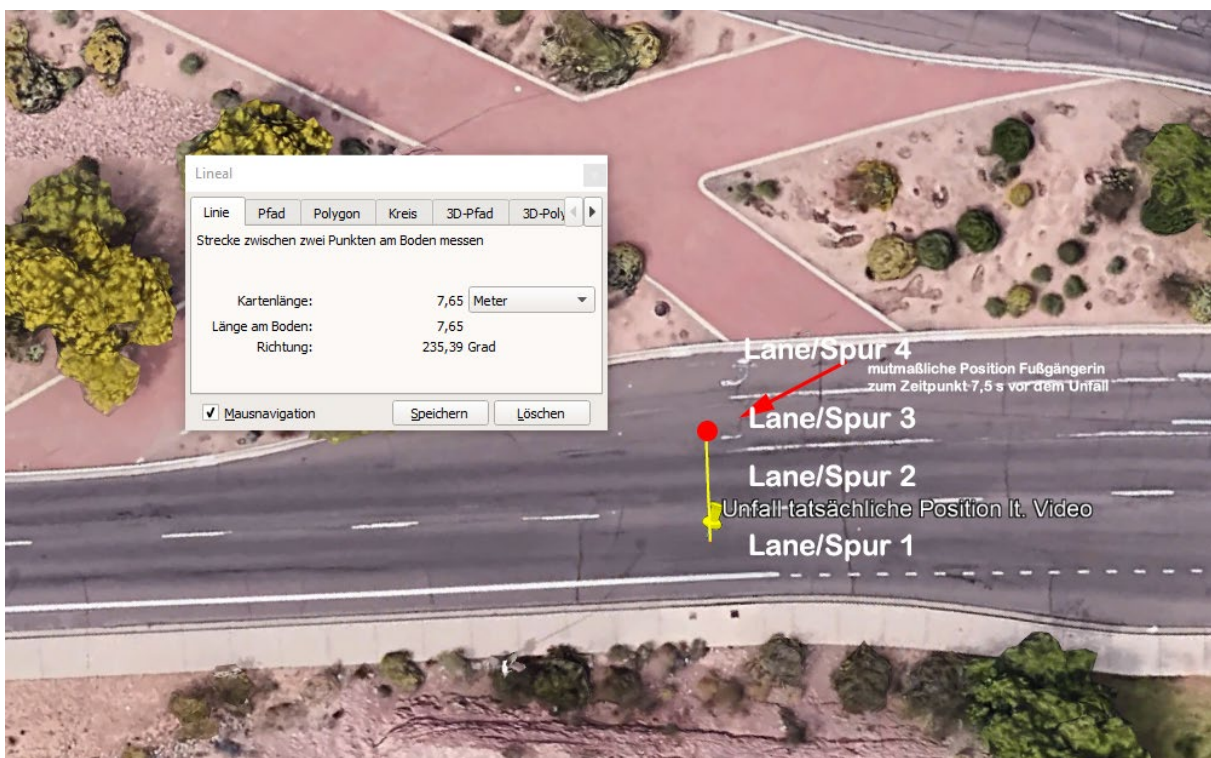
Illustration 20: Calculated movement of the pedestrian across the lanes

In the video provided by the police, it looks as if the woman with the bike would have been visible only about 1.5 seconds before the impact (time in the analysis video of the author of time code 00:00:12:19 to 00:00:14:05).

The video shows that she makes three steps from left to right in the right lane (lane 1) during this time. This corresponds approximately to a distance of 2.1 m (0.7 m per step). Thus, the accident victim moves with $v = 2.1 \text{ m} / 1.5 \text{ s} = 1.4 \text{ m} / \text{s}$. Extrapolating this speed to the period before becoming visible in the direction to the left (from where it was presumed to come from), it has about 2.8 m (lane 2) 3 s earlier and about 5.6 m (lane 3) further to the left.

Therefore, the woman was already on the road at least 7.5 seconds before the impact. The vehicle was at the time of the worst-case 45 mph = 72.42 km / h = 20.12 m / s fast. Thus, it was located 7.5 seconds before the impact about 150 meters from the scene of the accident. This point is under the bridge:

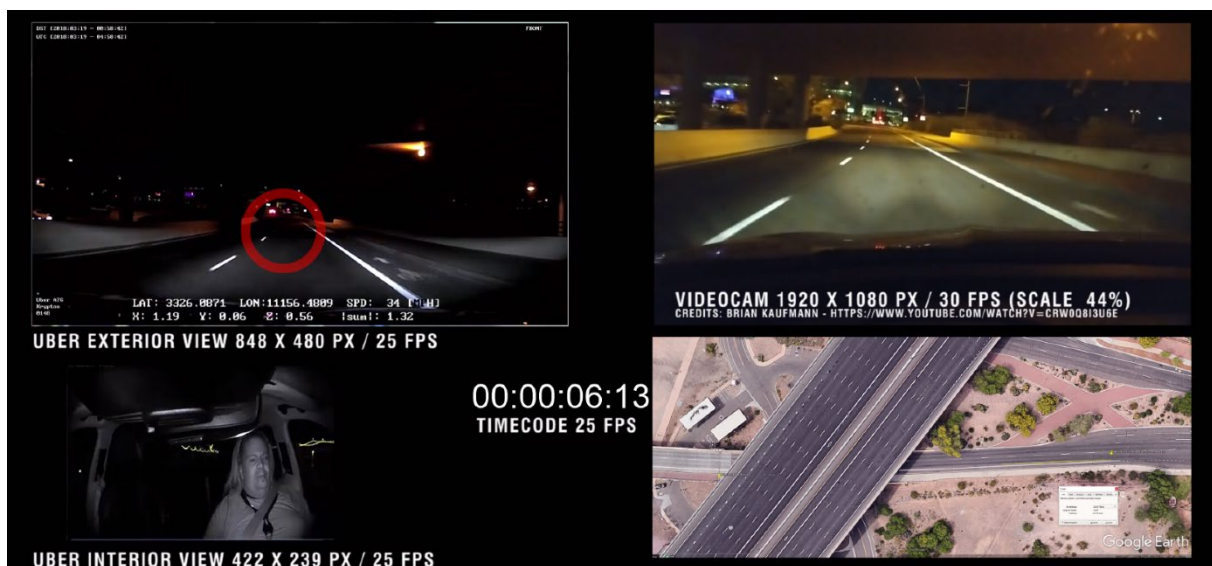
Illustration 22: Composite and synchronized video presentation

From the composite animation of the videos you can see that the driver of the Uber vehicle before the accident exactly at this point (time code 00:00:06:13) looked at the road for the last time and then did not look up until just before the impact.

The brighter comparison video shows that at that time the area of the turn lanes to the left of the main lanes was neither visible to sensors such as a LIDAR nor to a human driver. The woman was actually still in the shade of sight at this time.

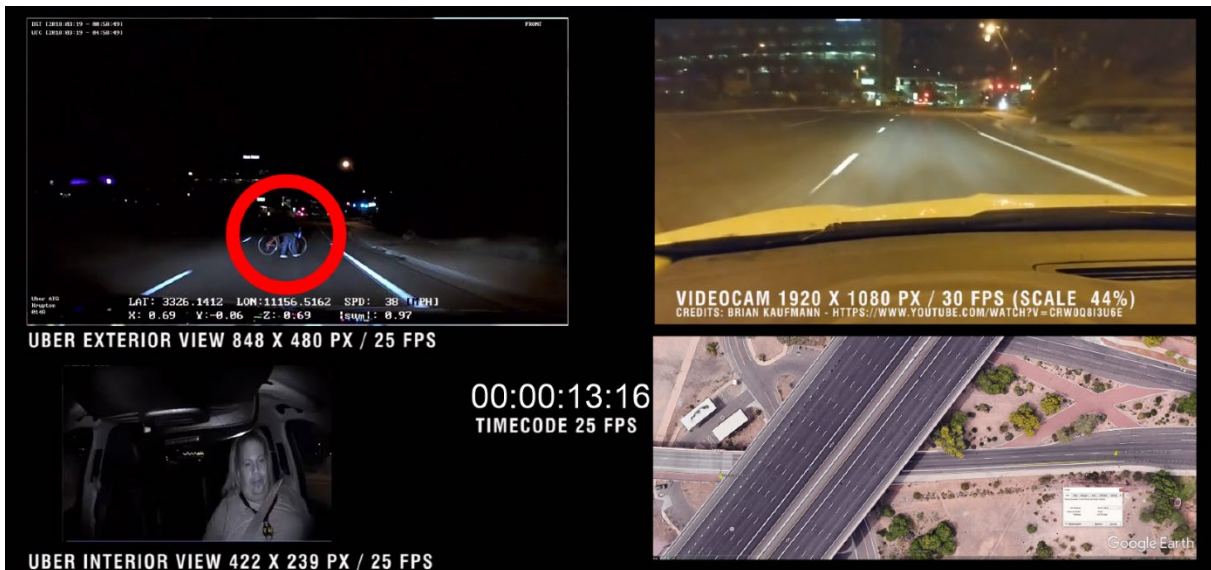
Illustration 24: Synchronized video presentation at the time just before the accident

In fact, the human driver first looked at the roadway a second before the impact and used up the entire one-second reaction time allowed to a human driver until a reaction was made.

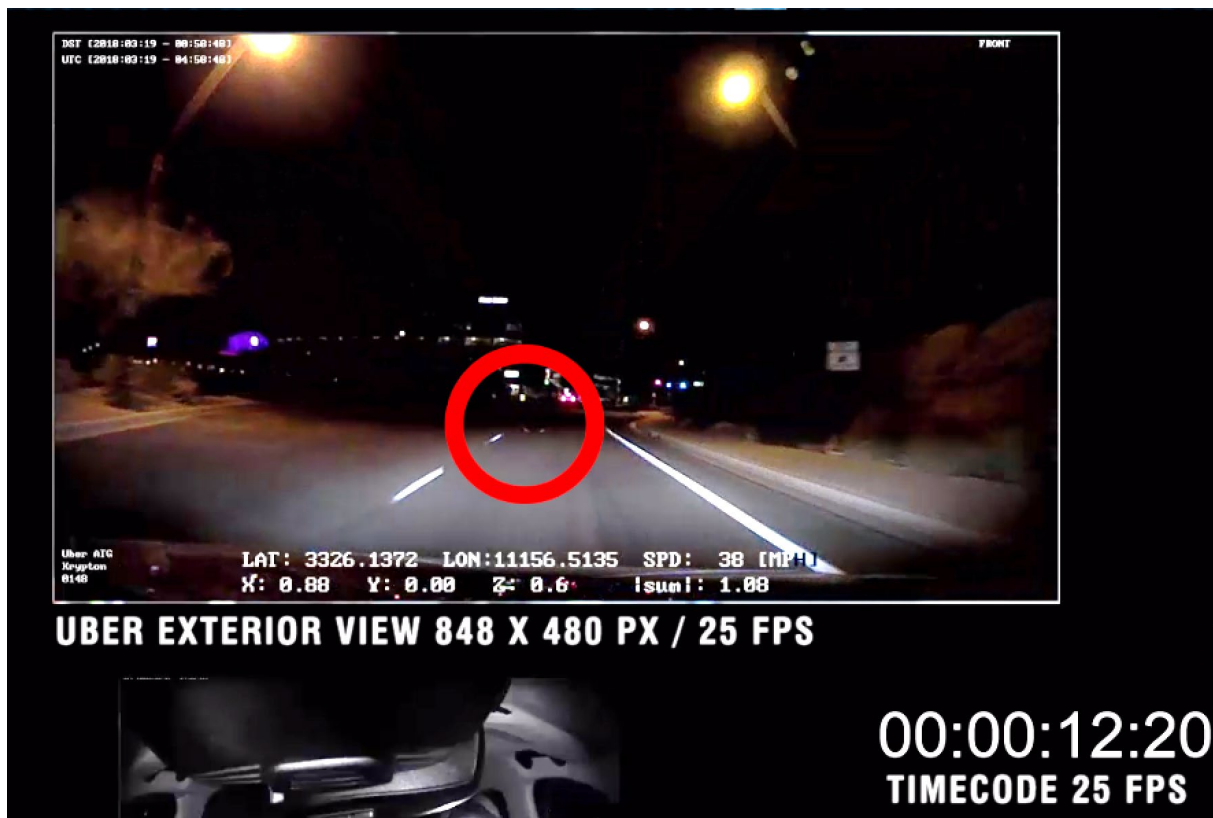
Illustration 26: Latest time to become visible in the police video

At latest at time code 00:00:12:20 and thus 1.4 seconds before impact, the victim is also visible in the dark video of the Uber vehicle and definitely in the detection range of the sensors themselves of a today in modern vehicles usual front collision warning on radar and / or camera base.

1.4 seconds before the impact, the vehicle still had a distance of at least 28 m to the accident victim. This would have led to an evasive maneuver against the direction of the woman and with a simultaneous braking to a pure braking distance of about 33.7 m. The residual velocity in a 28 m impact would have been just under 30 km / h instead of 72 km / h, resulting in less than a quarter of the impact kinetic energy. Possible meadow alone would have prevented the pedestrian from being fatally injured.
