Forensic Report Accident Uber-Volvo 18.03.2018 (Extract from Research Project Car-Forensics)

Forensic Report Accident Uber-Volvo 18.03.2018 in Tempe, Arizona (USA)

Release date: 02 April 2018

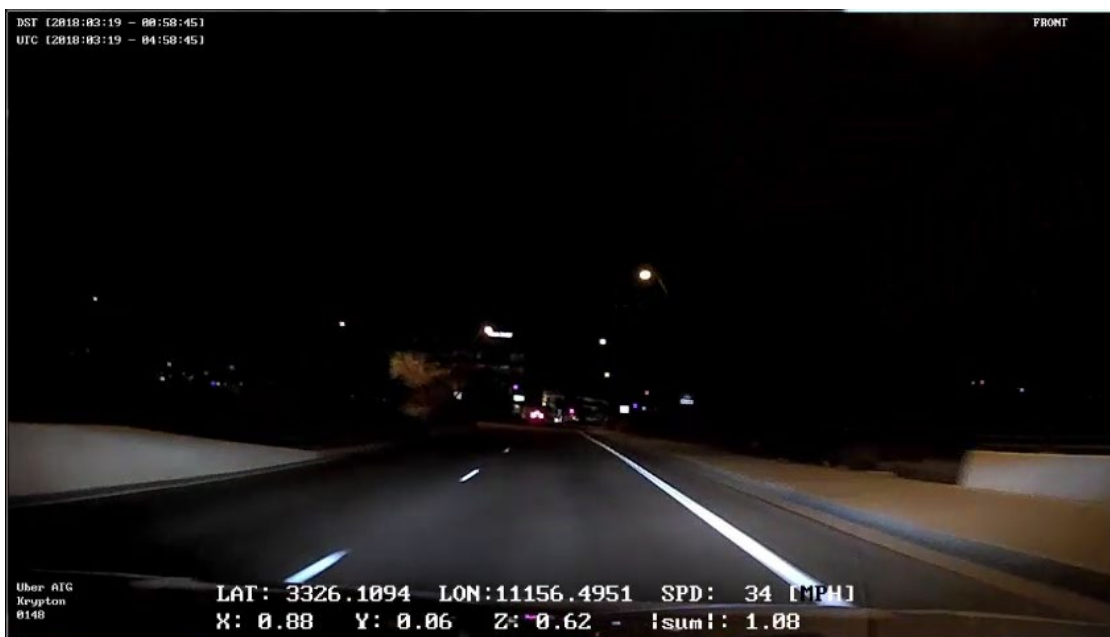
Illustration 9: Front camera image about 120 m before the accident

That means the vehicle has had a speed of about 45 mph in the last 70 m before the impact. According to the video (metadata), the vehicle accelerated in this area from 34 mph to about 40 mph directly on impact and then increased the speed to 42 mph after the accident. The latter is completely implausible, since that would mean that the car would have accelerated again when hitting the victim. In fact, it will have been slowed down by the impact. The findings on the previous page also explain this apparent contradiction. The speed values shown in the video, in contrast to the acceleration values X, Y and Z detected in real time, are outdated by several seconds and refer to the roadway about 76 m to 108 m further ahead of the accident. It is also plausible that the vehicle accelerated there, as the speed limit was raised from 35 mph to 45 mph from the time the bridge was driven under, as shown immediately.

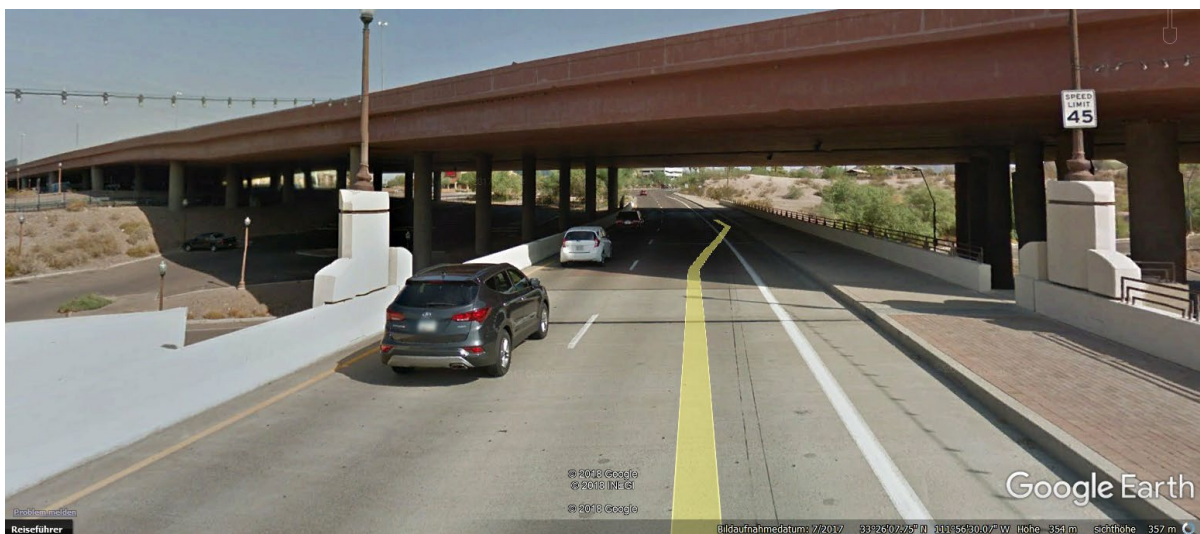
Illustration 12: Google Streetview Shot of the 45 mph sign by day

It is therefore very likely that the vehicle was between 42 and 45 mph at the time of the accident. Now, the police initially claimed that there is a speed limit of 35 mph at this point. Thus, the vehicle would have been automated too fast.

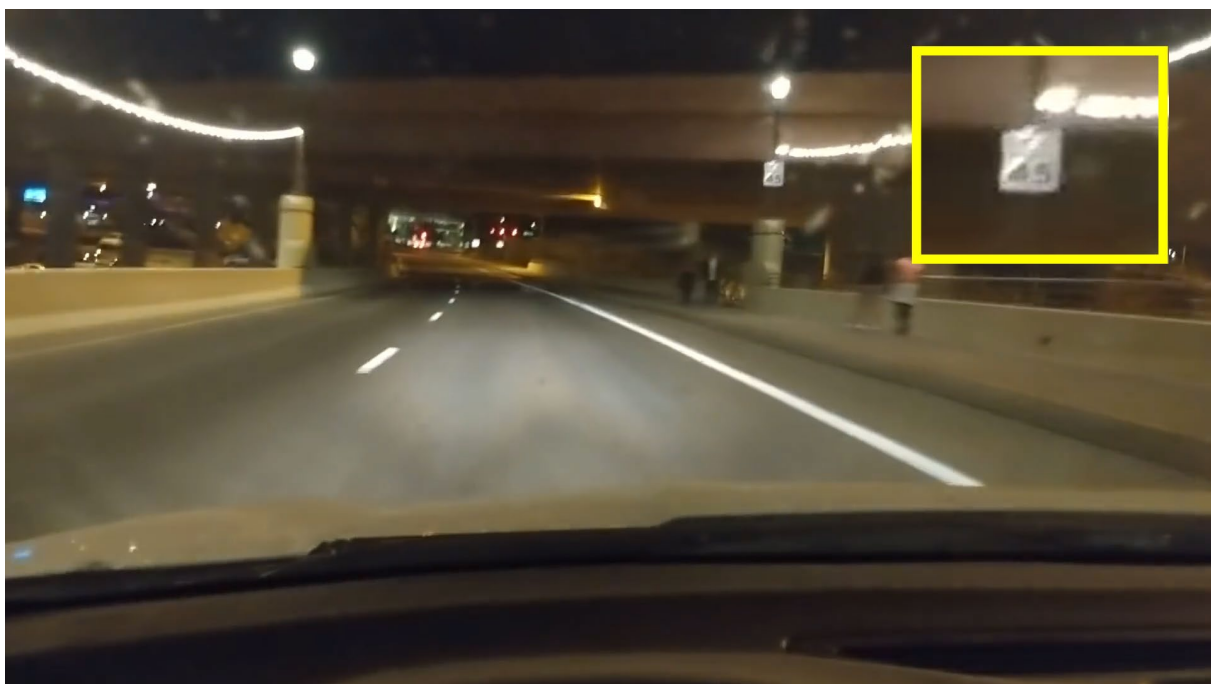
Illustration 14: Shot of the 45 mph shield from a reference vehicle at night.

Moreover, on another on-the-internet video of the situation at night (recorded on March 21, 2018 by Brian Kaufman you can see the 45 mph limitation¹⁵.

Since this video also shows the area behind the accident, it becomes clear that after the 45 mph limit to the accident, there is no new deviating speed limit. This proves that there was a limit of 45 mph at the scene of the accident and not, as many erroneously claimed, 35 mph.

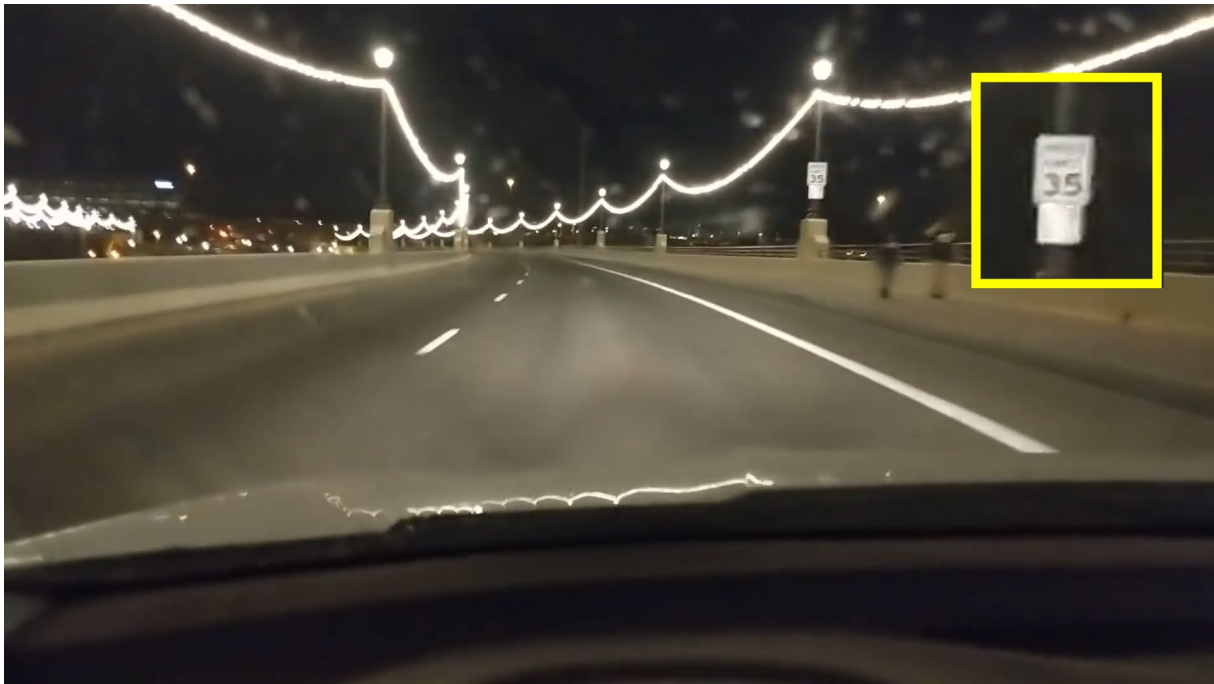
Illustration 15: Take the previous 35 mph shield from the reference vehicle at night

From the same video, you can also see at the beginning of the ride that there is a 35 mph limit several hundred meters before the bridge crossing:

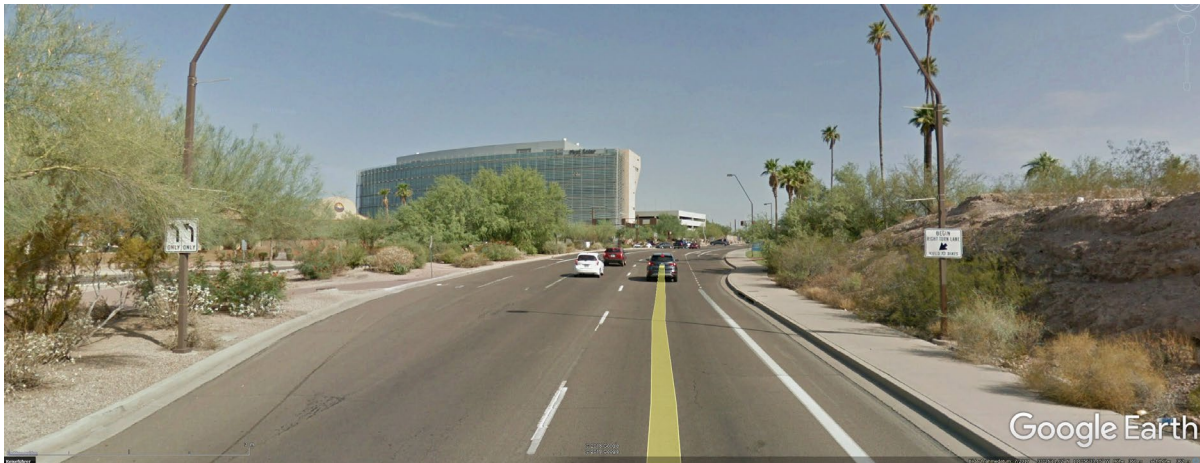
Illustration 19: Accident site by day (Google Streetview)

It can be clearly seen that the entire street is very well lit and an obstacle, such as a person crossing a bicycle pushing a bicycle would be easily recognizable.

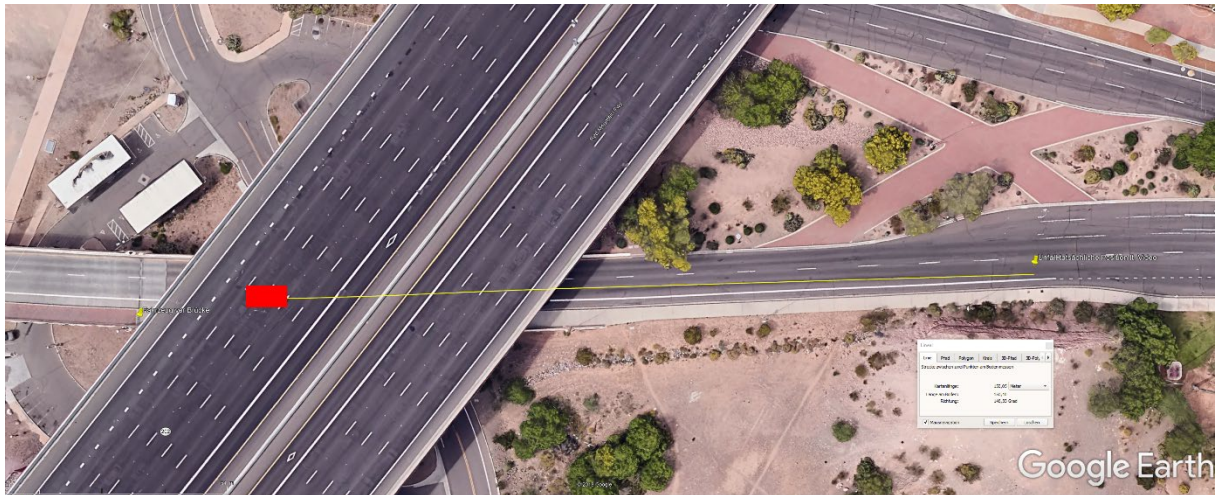
Illustration 21: Overview of the accident site via Google Earth

Therefore, the woman was already on the road at least 7.5 seconds before the impact. The vehicle was at the time of the worst-case 45 mph = 72.42 km / h = 20.12 m / s fast. Thus, it was located 7.5 seconds before the impact about 150 meters from the scene of the accident. This point is under the bridge:

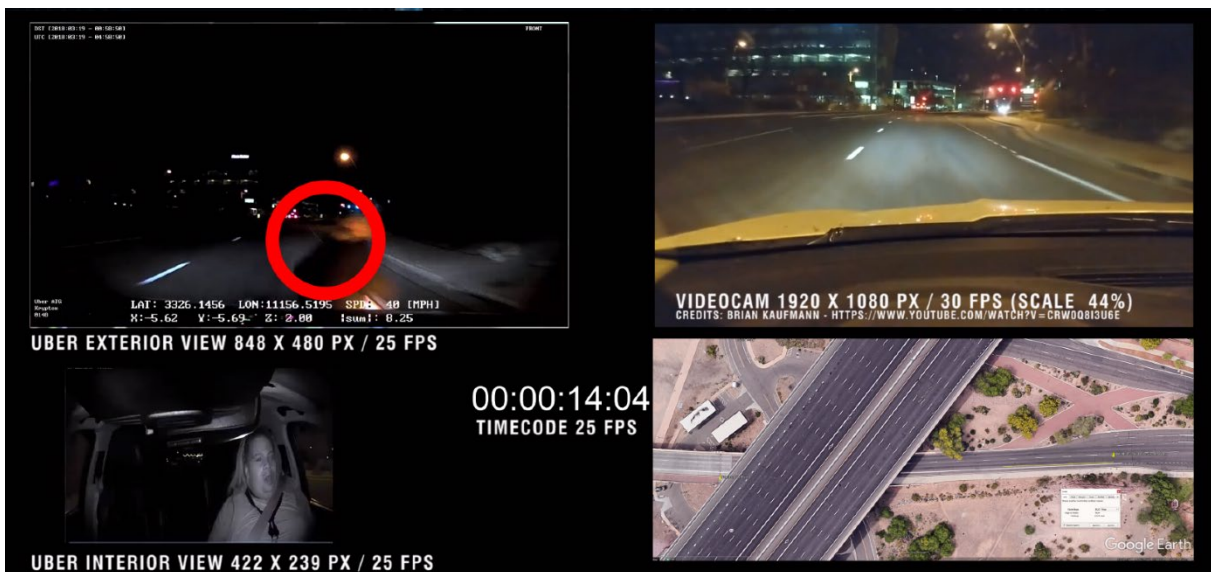
Illustration 25: Synchronized video presentation at the time of the impact

The impact is documented about 1 second later with time code 00:00:14:04.

At latest at time code 00:00:12:20 and thus 1.4 seconds before impact, the victim is also visible in the dark video of the Uber vehicle and definitely in the detection range of the sensors themselves of a today in modern vehicles usual front collision warning on radar and / or camera base.
